Appendix E

Photograph Log and Photographs

DC Water CSO 019, DC Clean Rivers Division C
Construction Stormwater Inspection Report

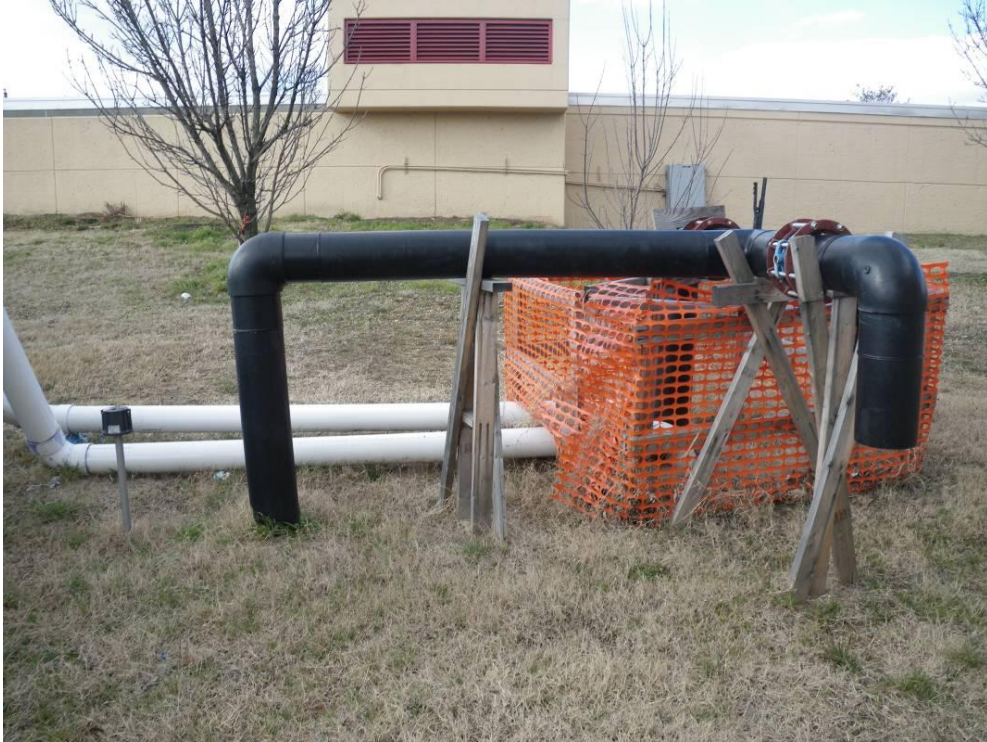
Photograph 5. Piping that connects DC Water pumping station to collection tank for settling.

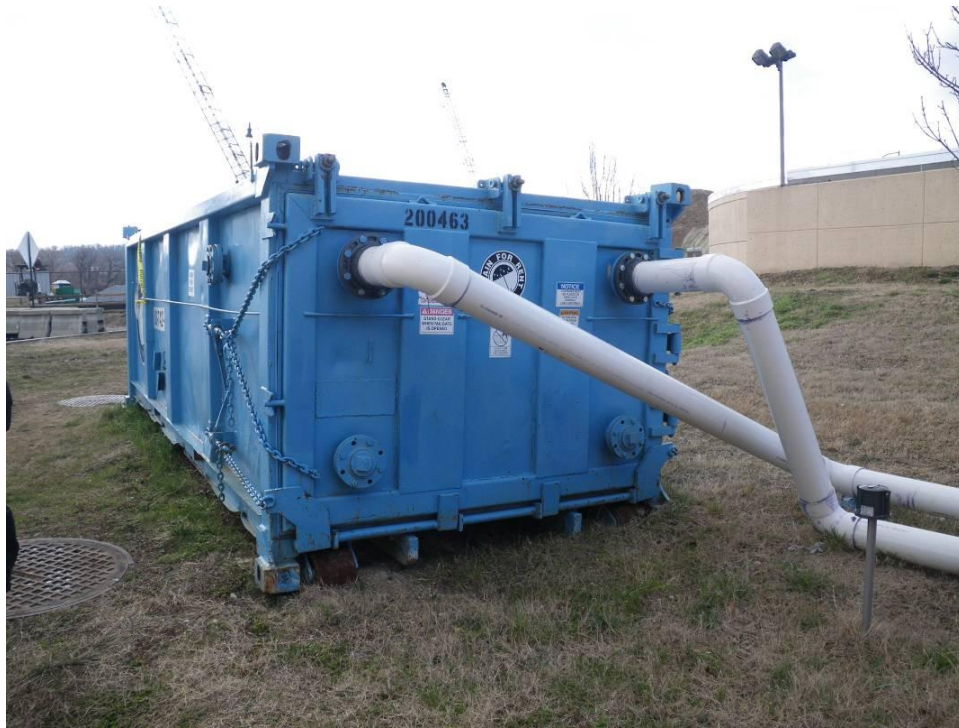
Photograph 6. Collection tank near the pumping station to provide for sediment removal by settling.

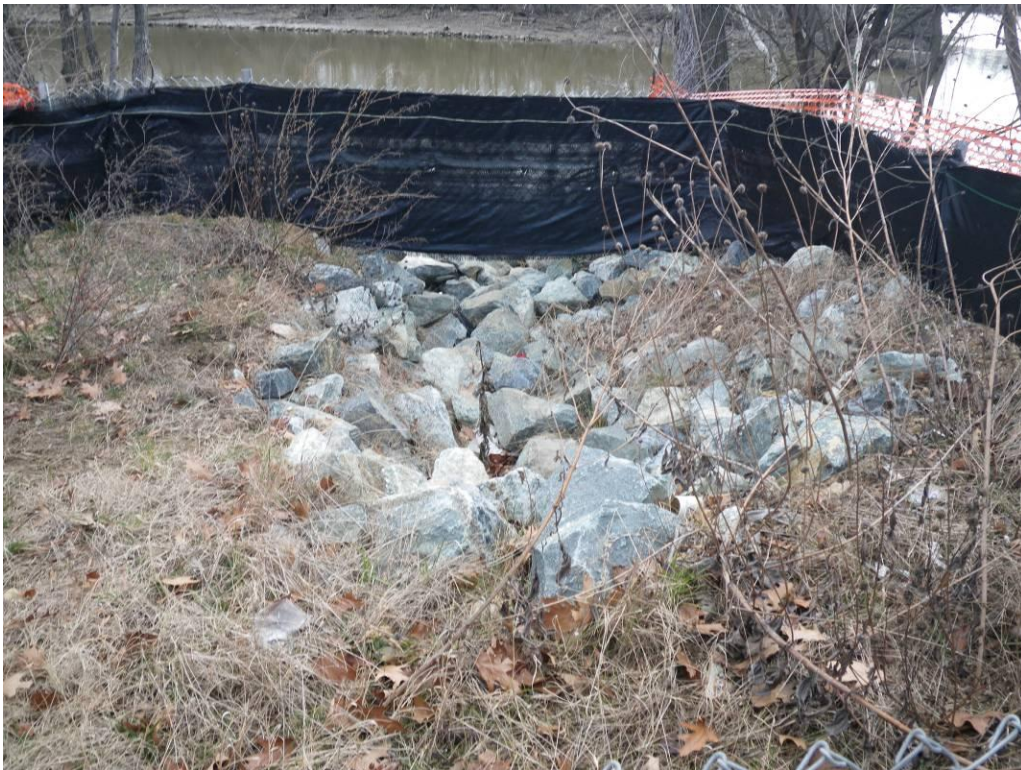
Photograph 8. Riprap and silt fence near Outfall 1.

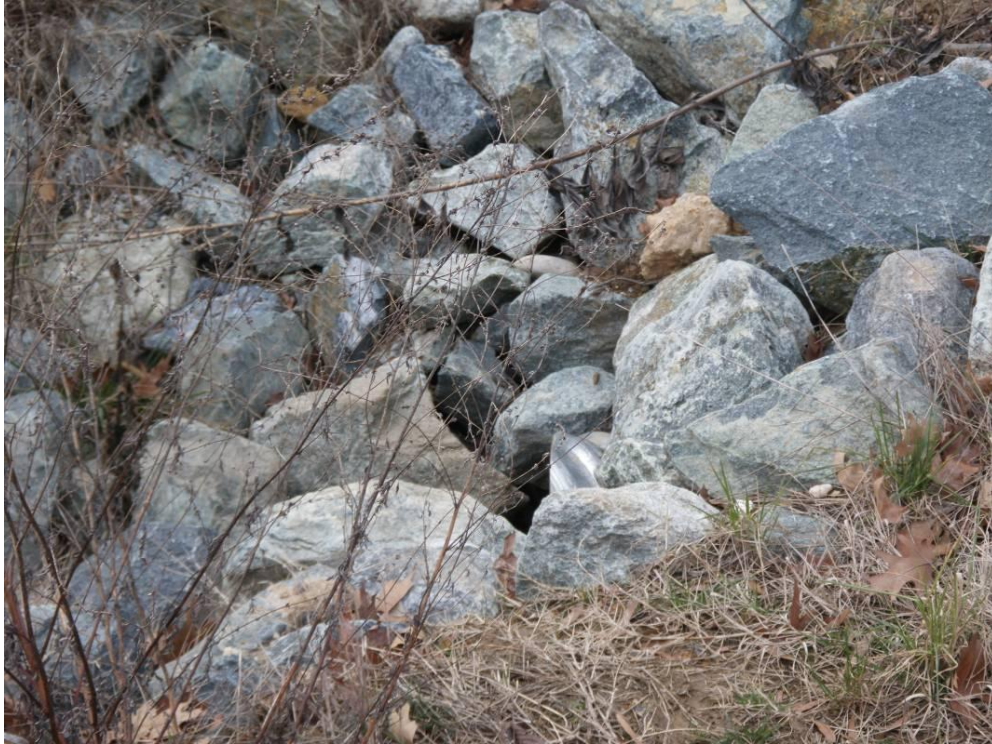
Photograph 9. **Close up of riprap and Outfall 1 (16 in CMT).**

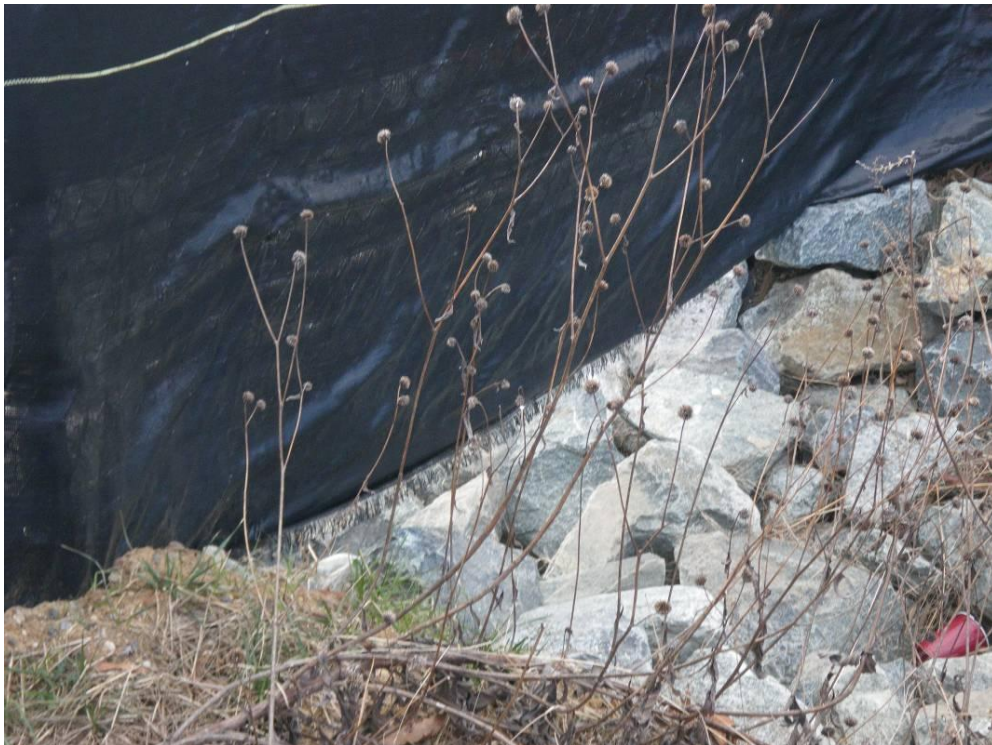
Photograph 10. **Gap between silt fence and riprap near Outfall 1.**

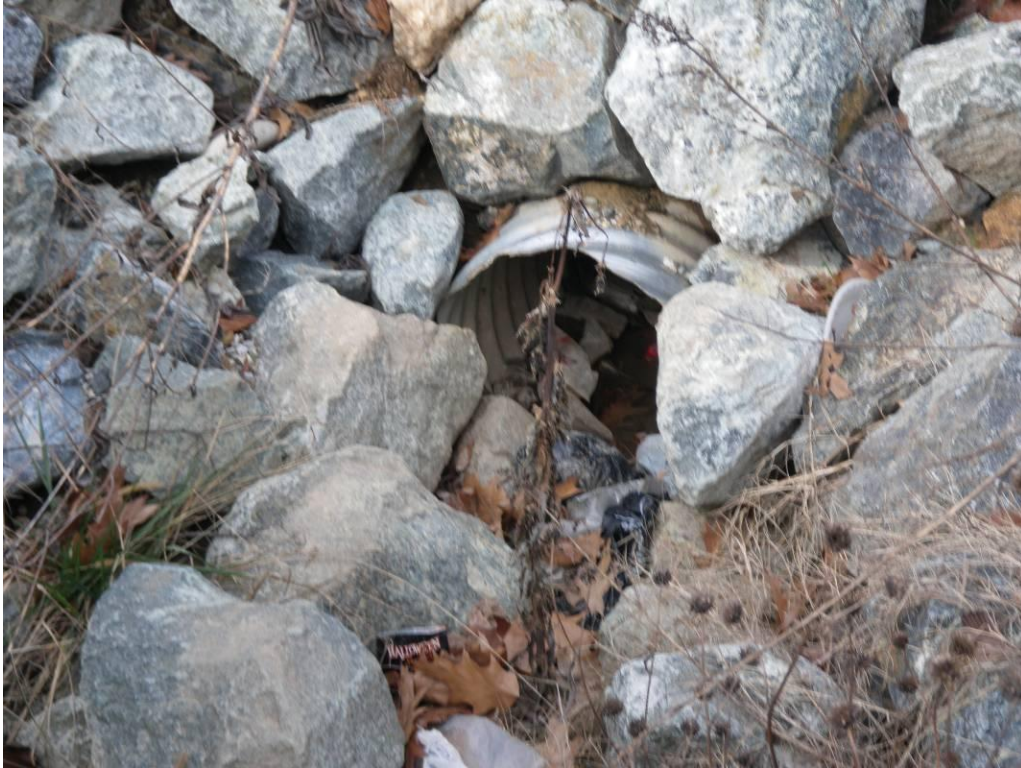
Photograph 11. Sediment on riprap located downstream of the Outfall 1 pipe.

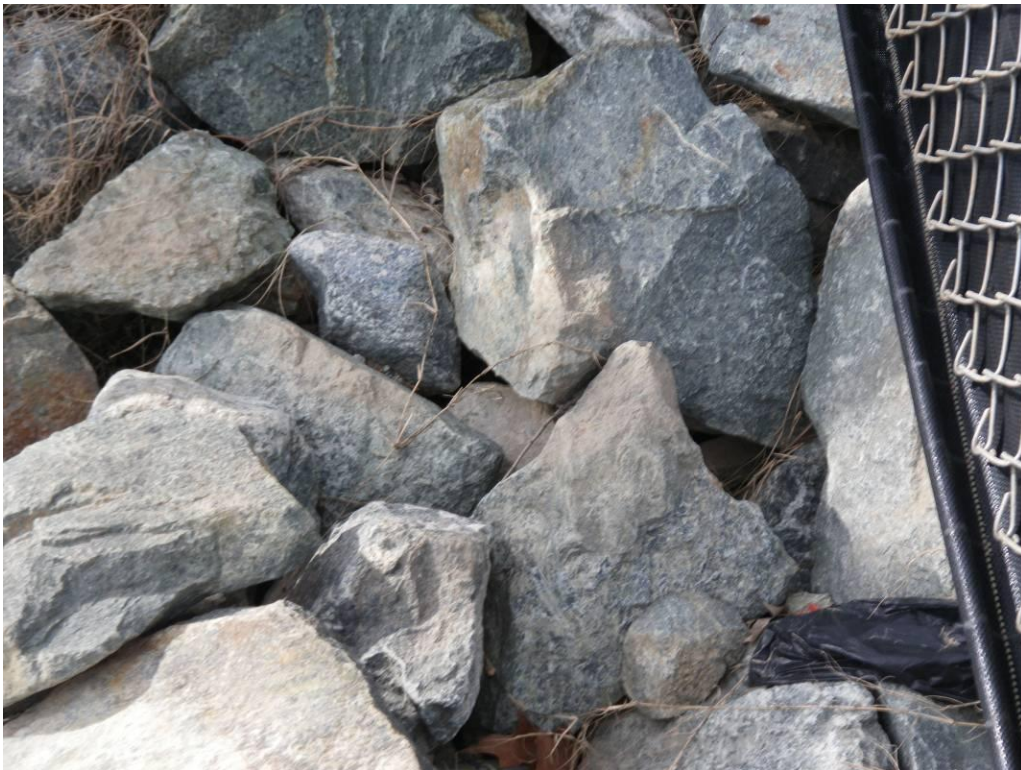
Photograph 12. Close up view of sediment on the riprap near Outfall 1.

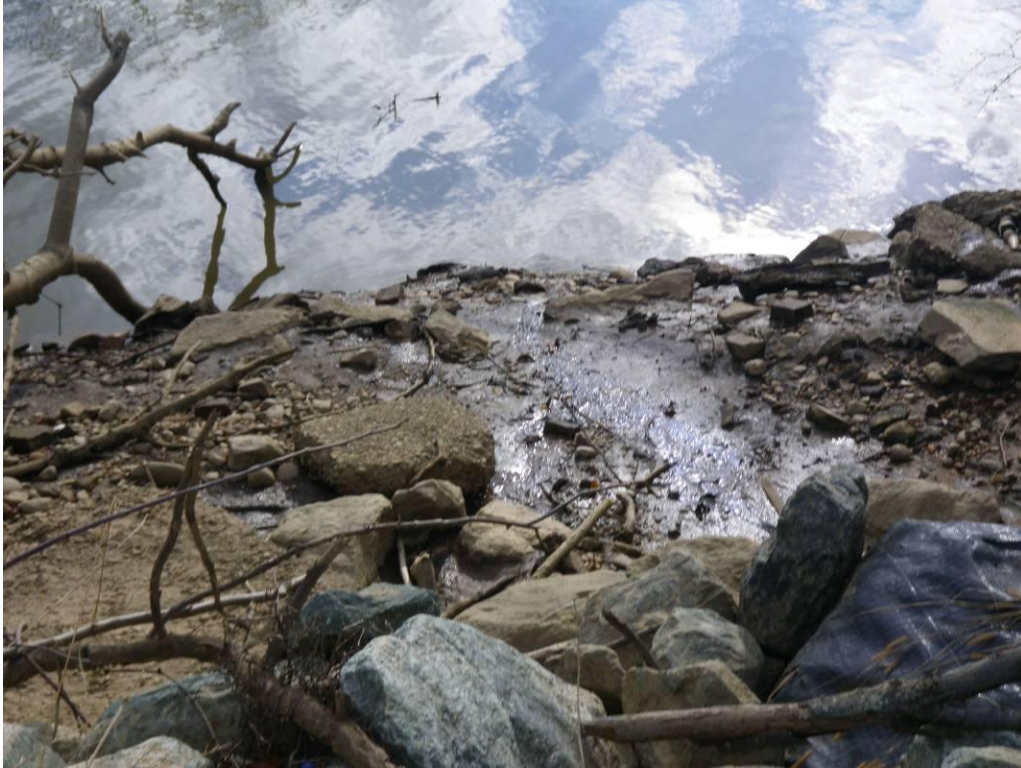
Photograph 13. Discharge flow path from Outfall 1 to the Anacostia River.

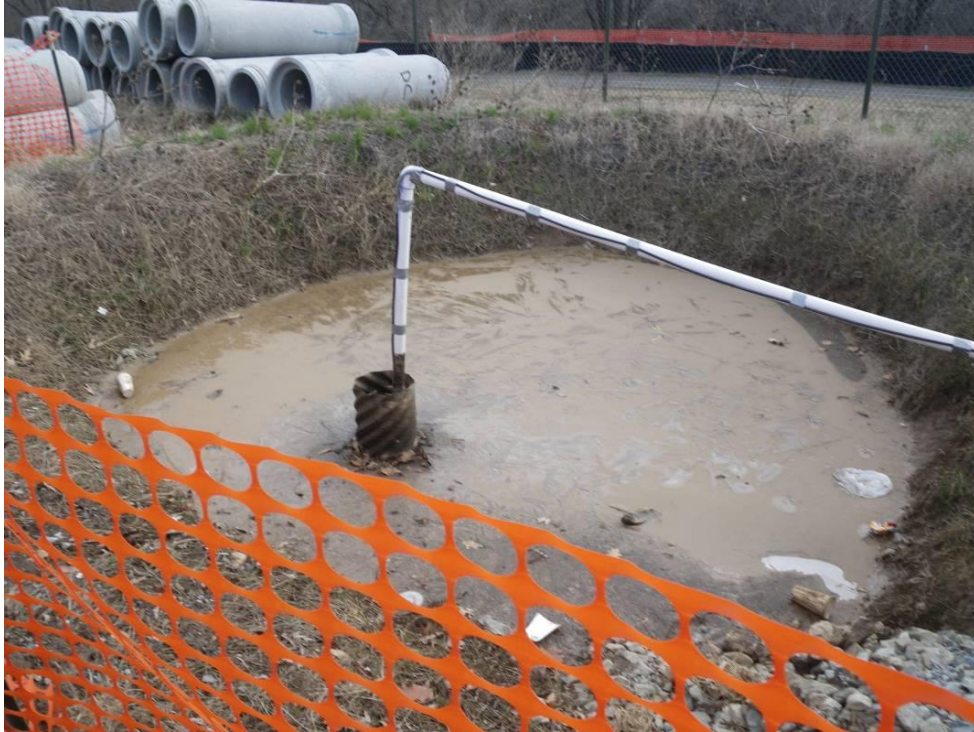
Photograph 15. Temporary sediment collection pit near Entrance 1. Water is pumped from the pit to Sediment Trap 1 before being discharged to the Anacostia River.

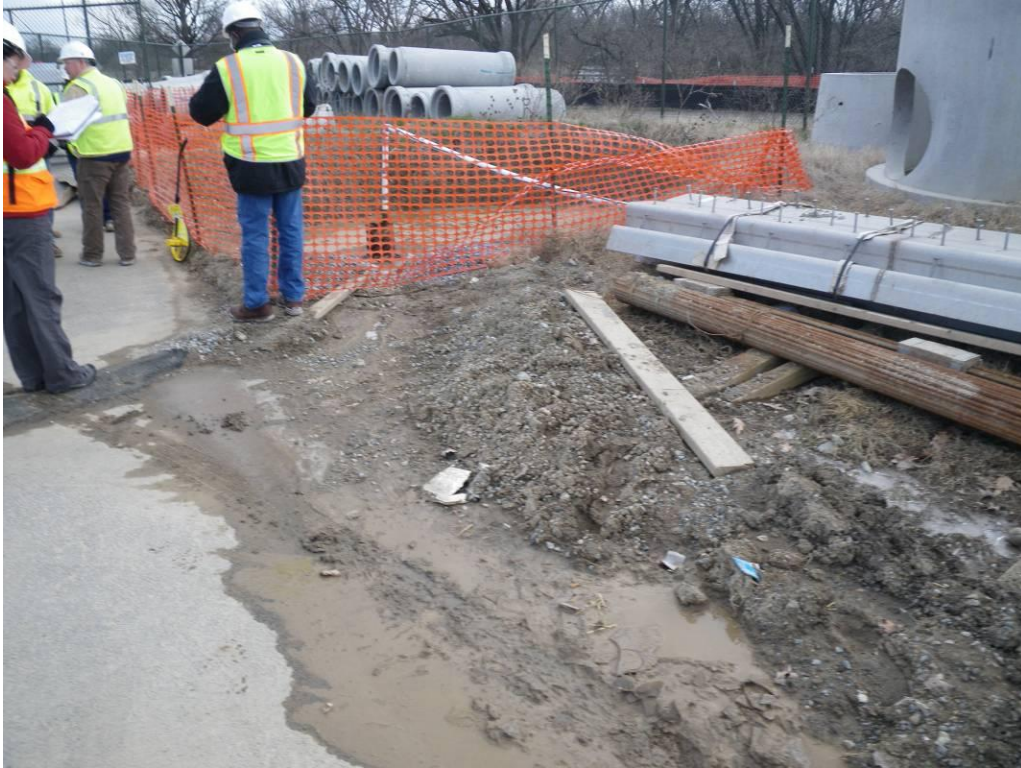
Photograph 17. Water pooling near temporary sediment pit at Entrance 1.

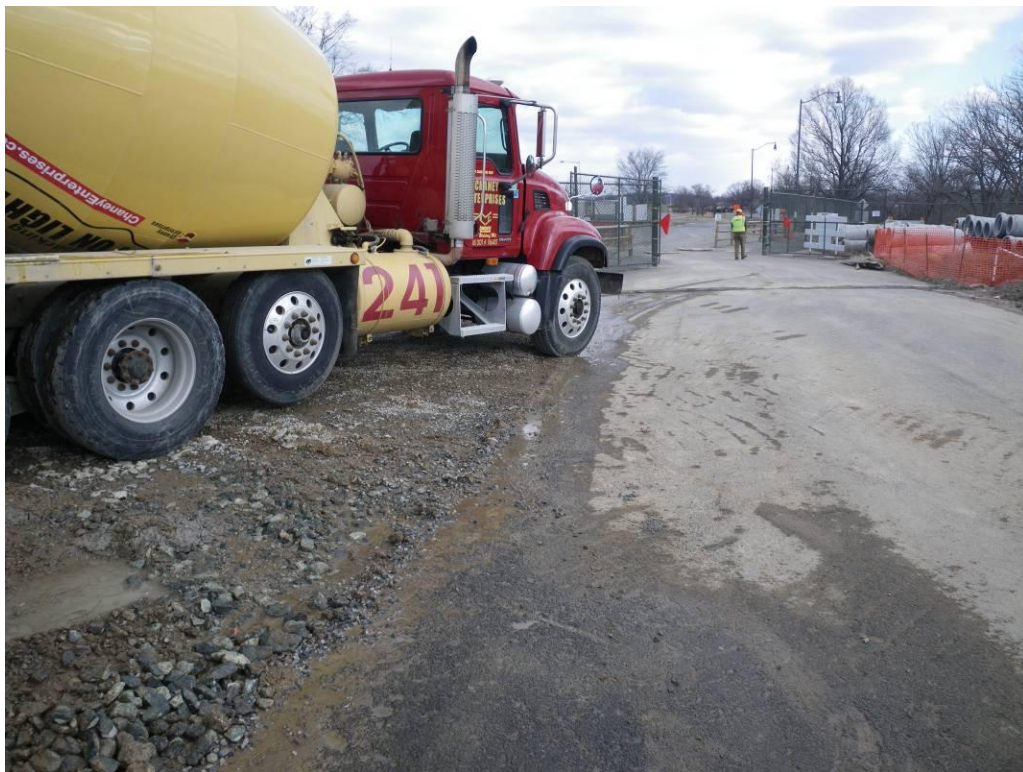
Photograph 20. Runoff from concrete truck washout area towards Entrance 1.

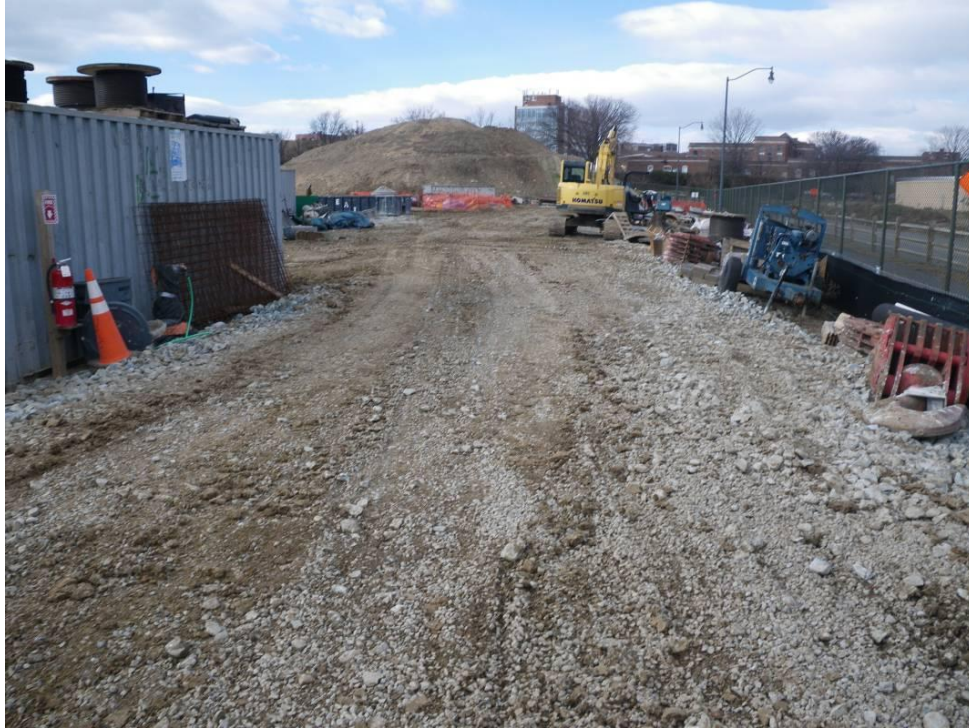
Photograph 23. **View from Entrance 1 looking into the site. Note sediment within the crushed aggregate.**

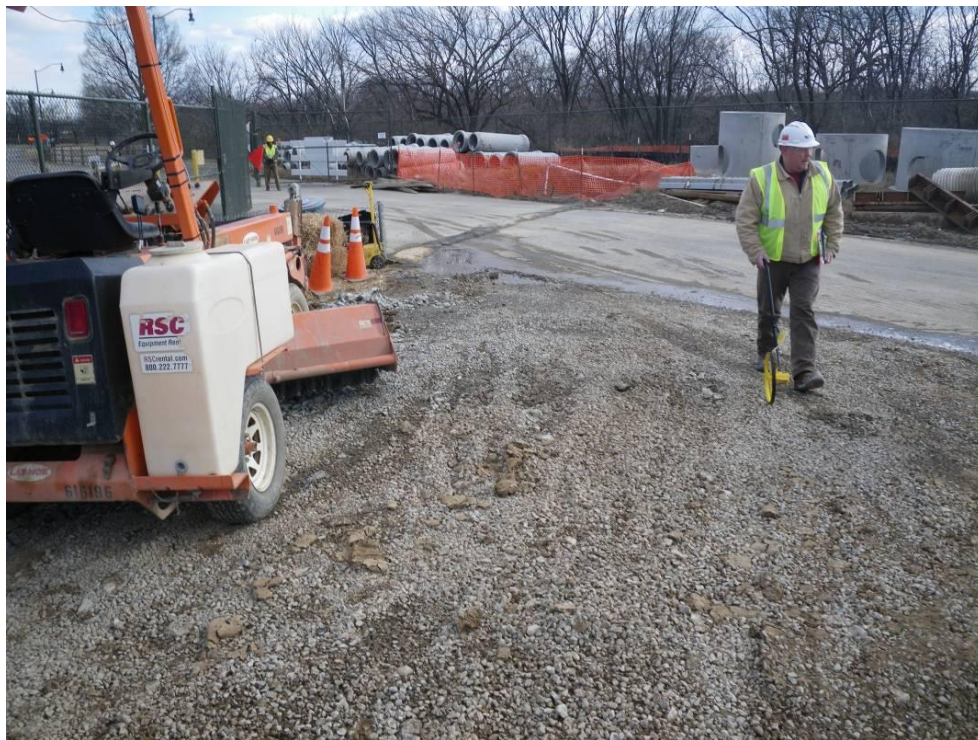
Photograph 24. **Sediment tracking onto pavement at Entrance 1.**

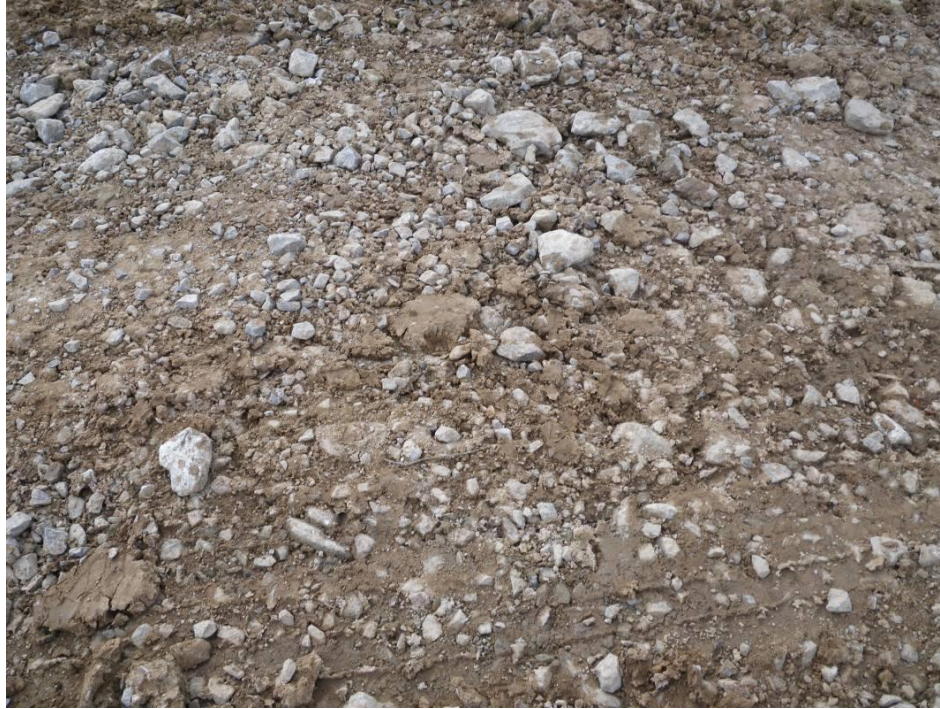
Photograph 25. Close-up view of sediment in crushed aggregate at Entrance 1.

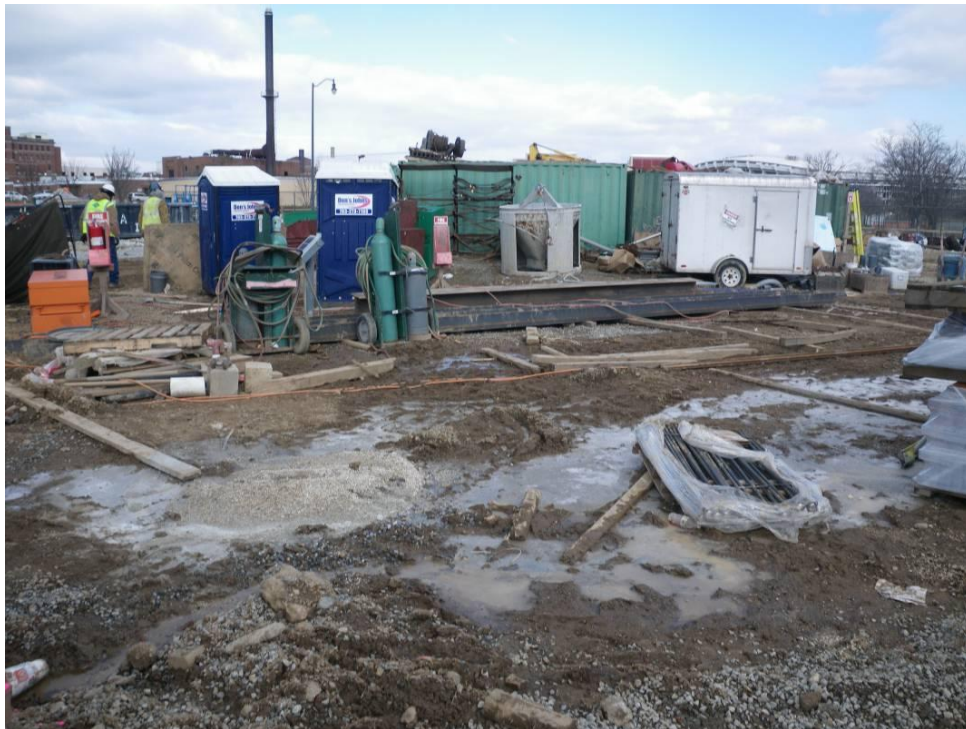
Photograph 28. **View of equipment staging area and hardened concrete primer.**

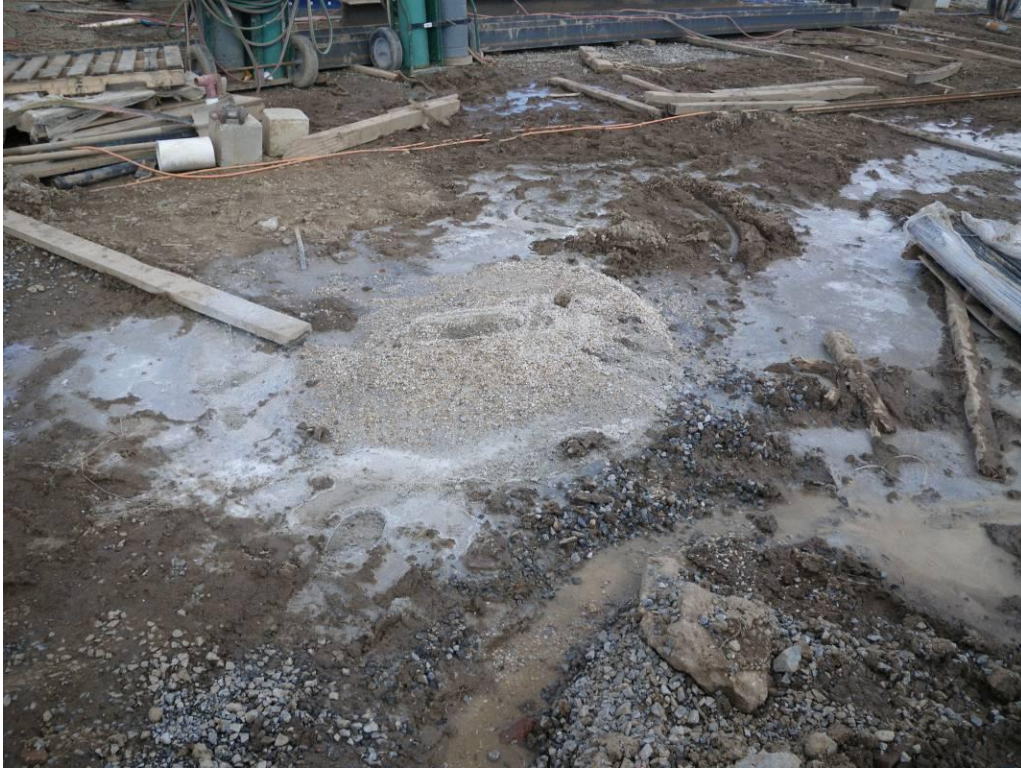
Photograph 29. Close-up view of hardened concrete primer waste.

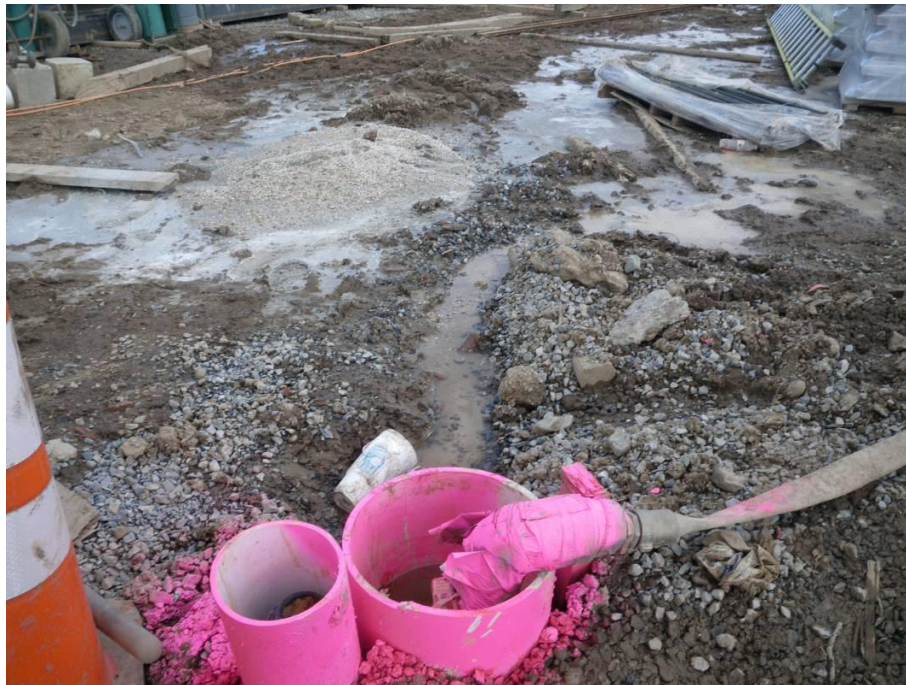
Photograph 30. Temporary potable water supply lines. According to site personnel, permanent water supply lines were broken during the inspection due to subfreezing temperatures.

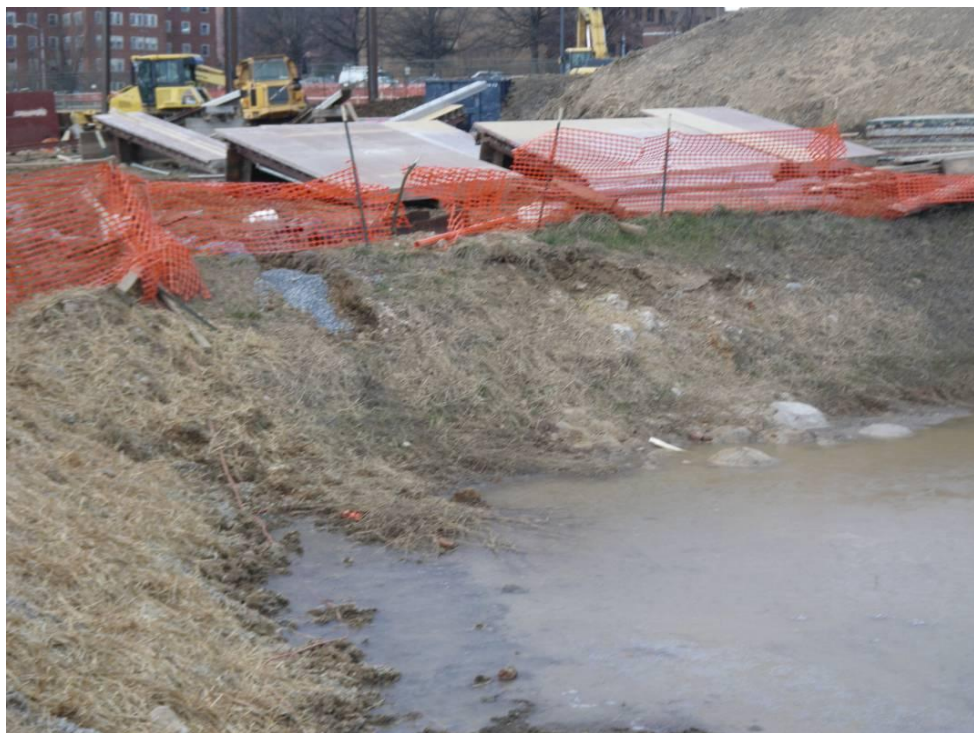
Photograph 32. View of erosion rills on the perimeter of Sediment Trap 1.

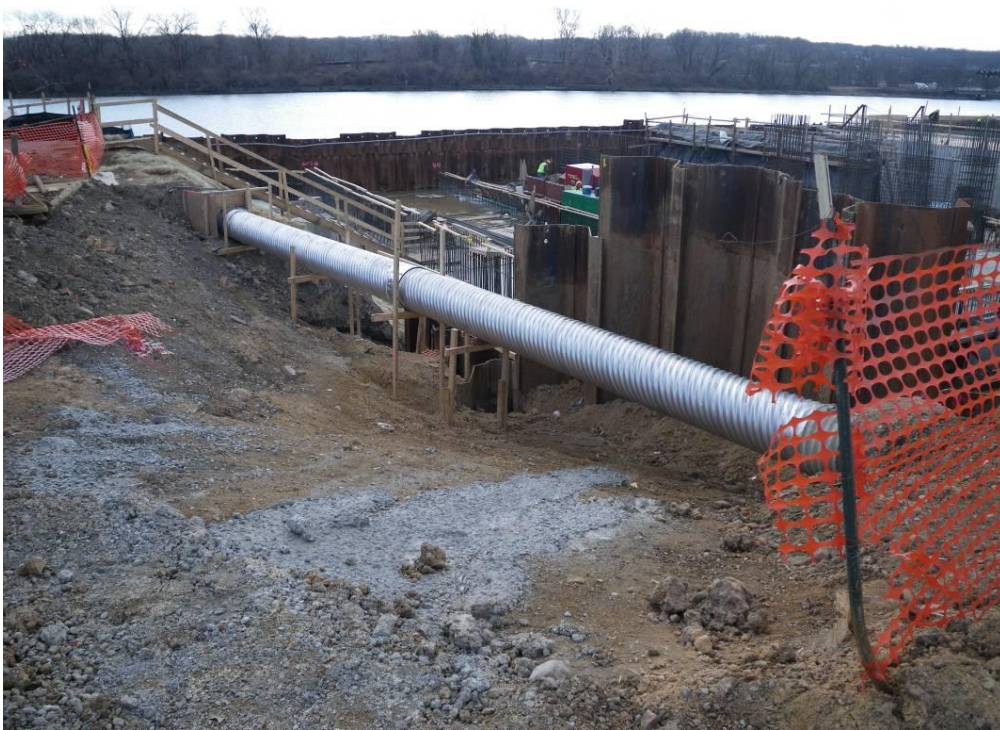
Photograph 34. Unstabilized slope and discharge pipe from Sediment Trap 1 to the Anacostia River.

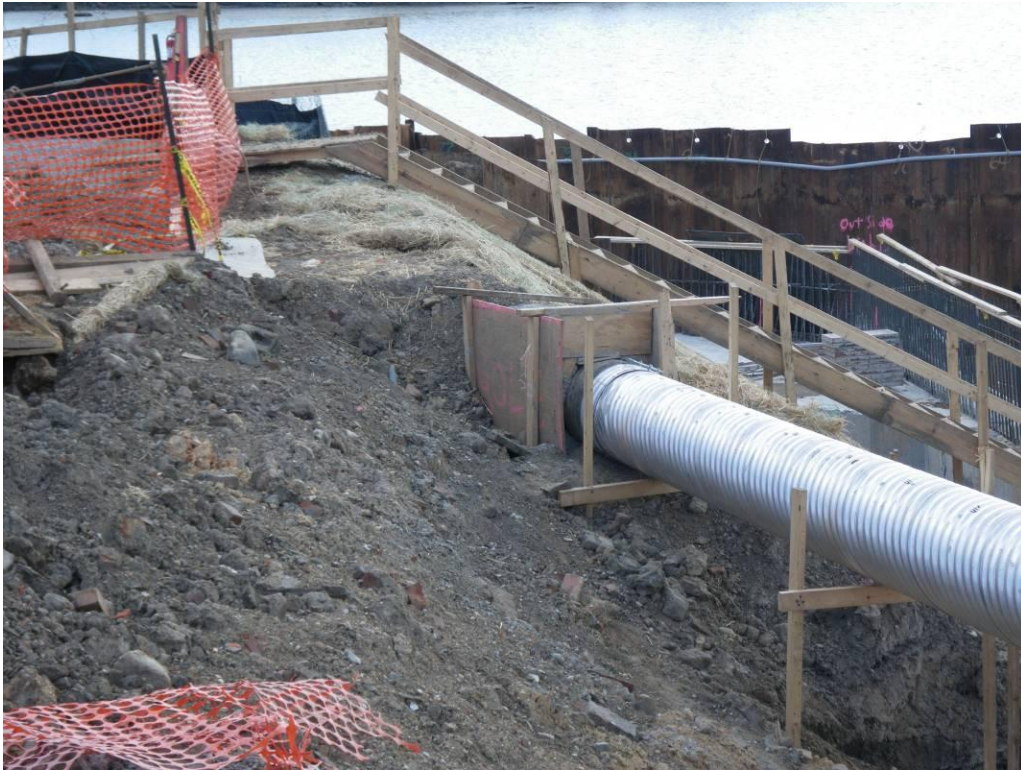
Photograph 35. Unstabilized slope and discharge pipe from Sediment Trap 1 to the Anacostia River.

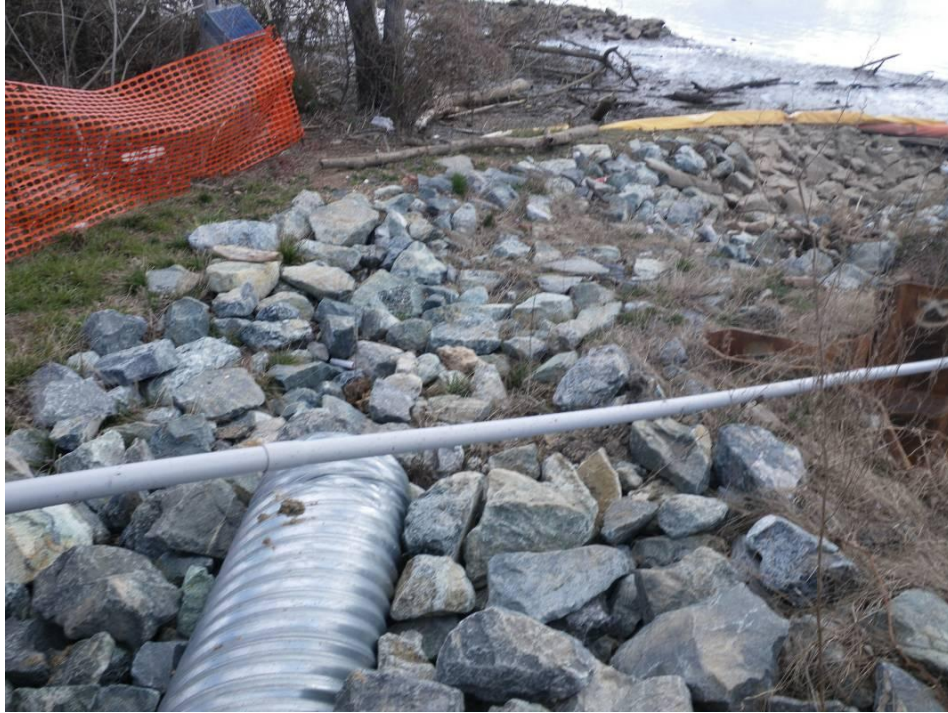
Photograph 39. Outfall from Sediment trap #1 and sediment laden riprap adjacent to the turbidity curtain.

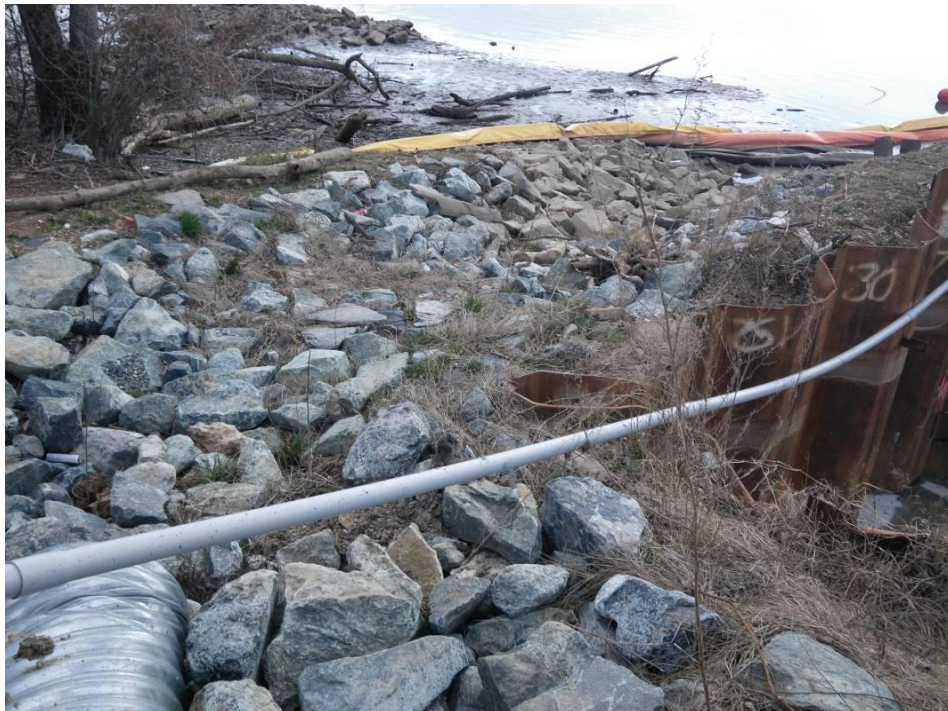
Photograph 40. Alternate view of the sediment laden riprap adjacent to the turbidity curtain.

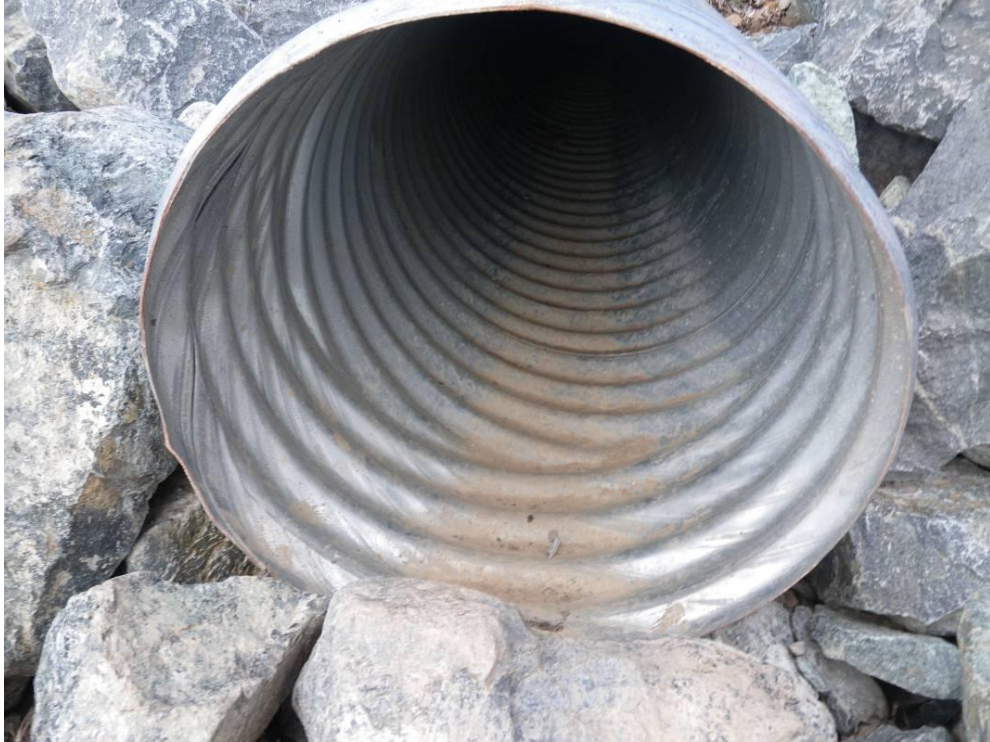
Photograph 41. View of sediment residue inside the outfall pipe leading from Sediment trap #1.

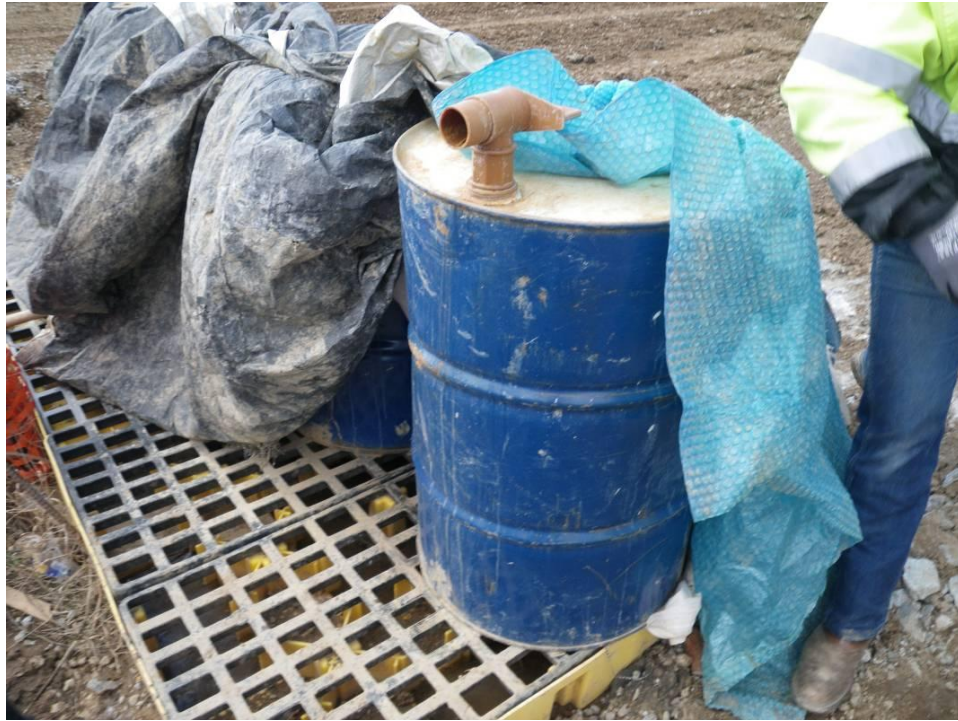
Photograph 43. Drums of unknown contents stored on top of secondary containment pallets.

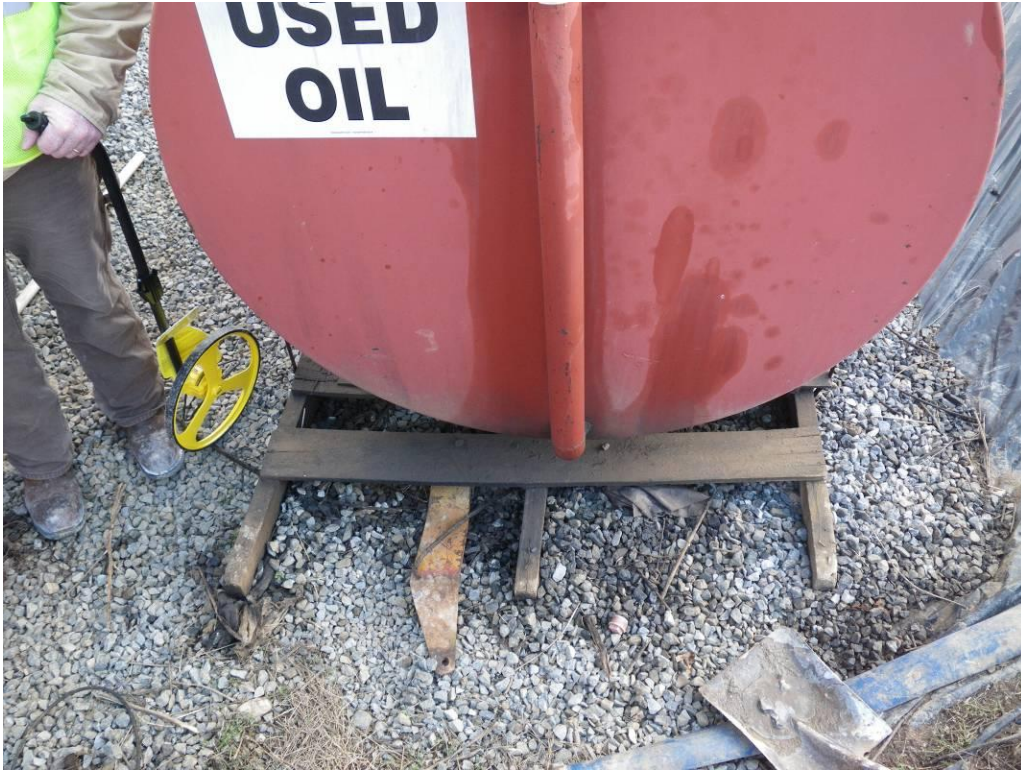
Photograph 47. Close-up view of oil staining on and around used oil tank.

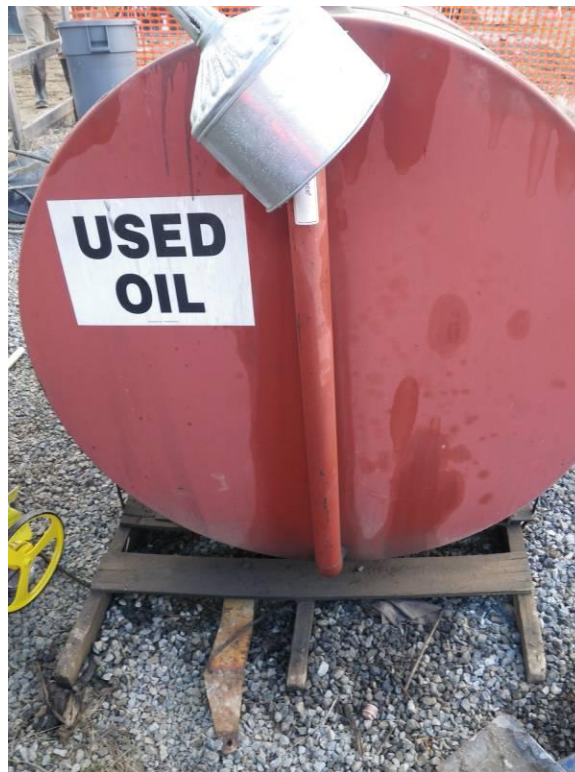
Photograph 48. Alternate view of oil staining on and around used oil tank.

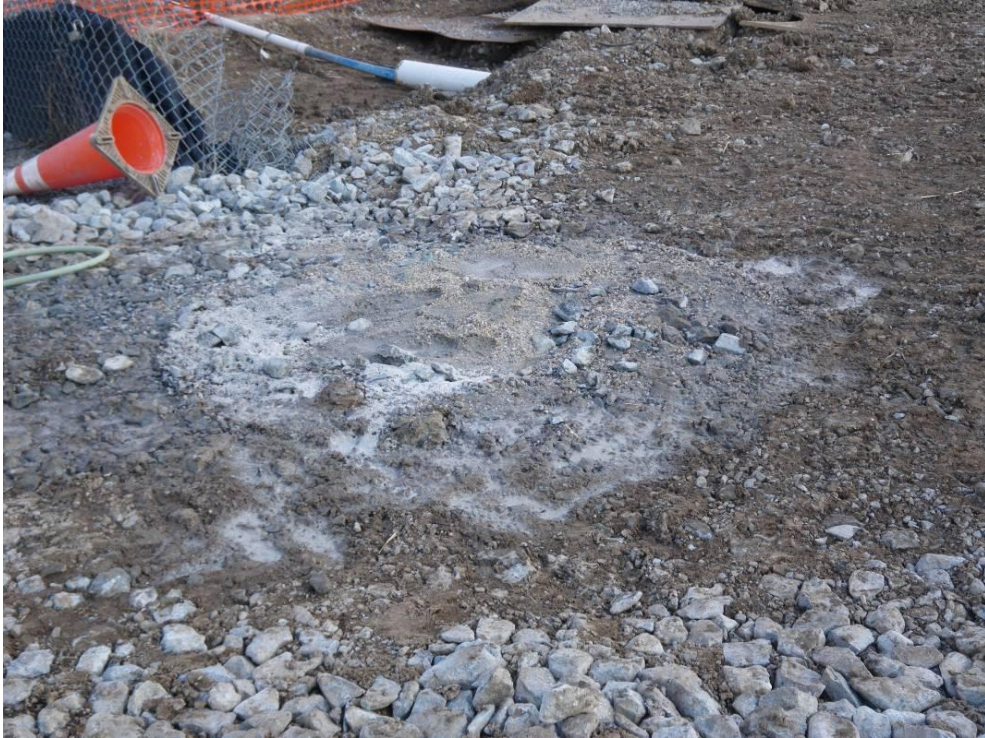
Photograph 51. View of concrete truck washout near Entrance 2 that had occurred outside of the designated concrete washout area.

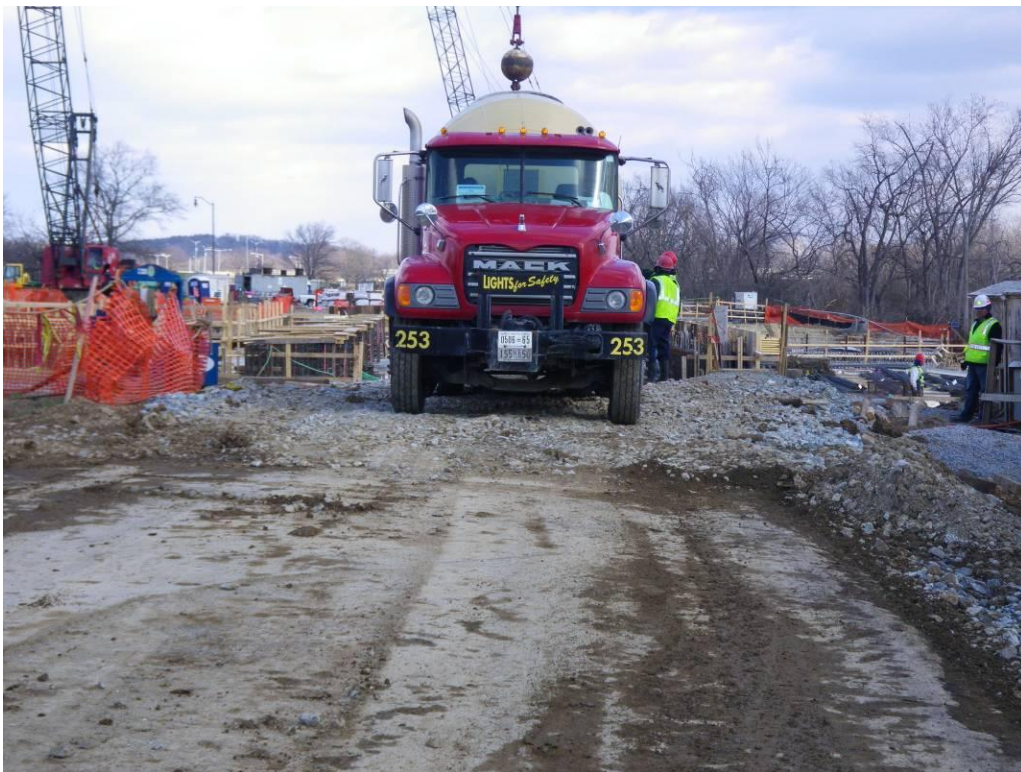
Photograph 58. Sediment tracking onto pavement at Entrance 3.

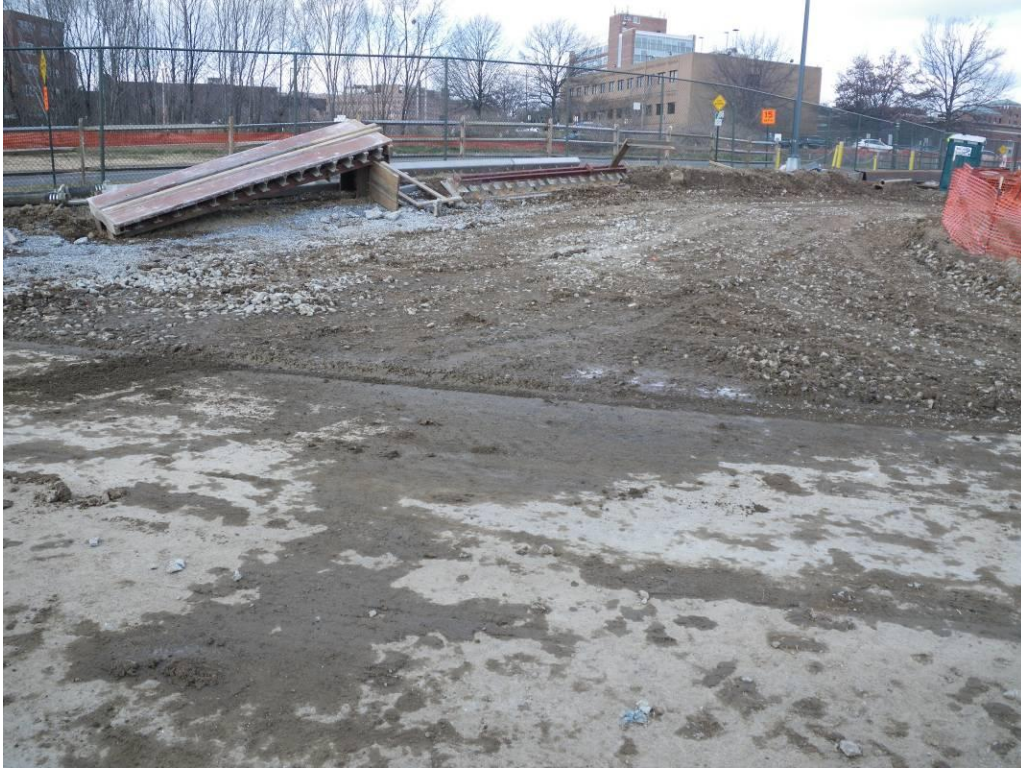
Photograph 59. **Alternate view of sediment tracking onto pavement.**
